## Chapter 9

# FIRE BEHAVIOR IN WORLD TRADE CENTER 2

### 9.1 INTRODUCTION

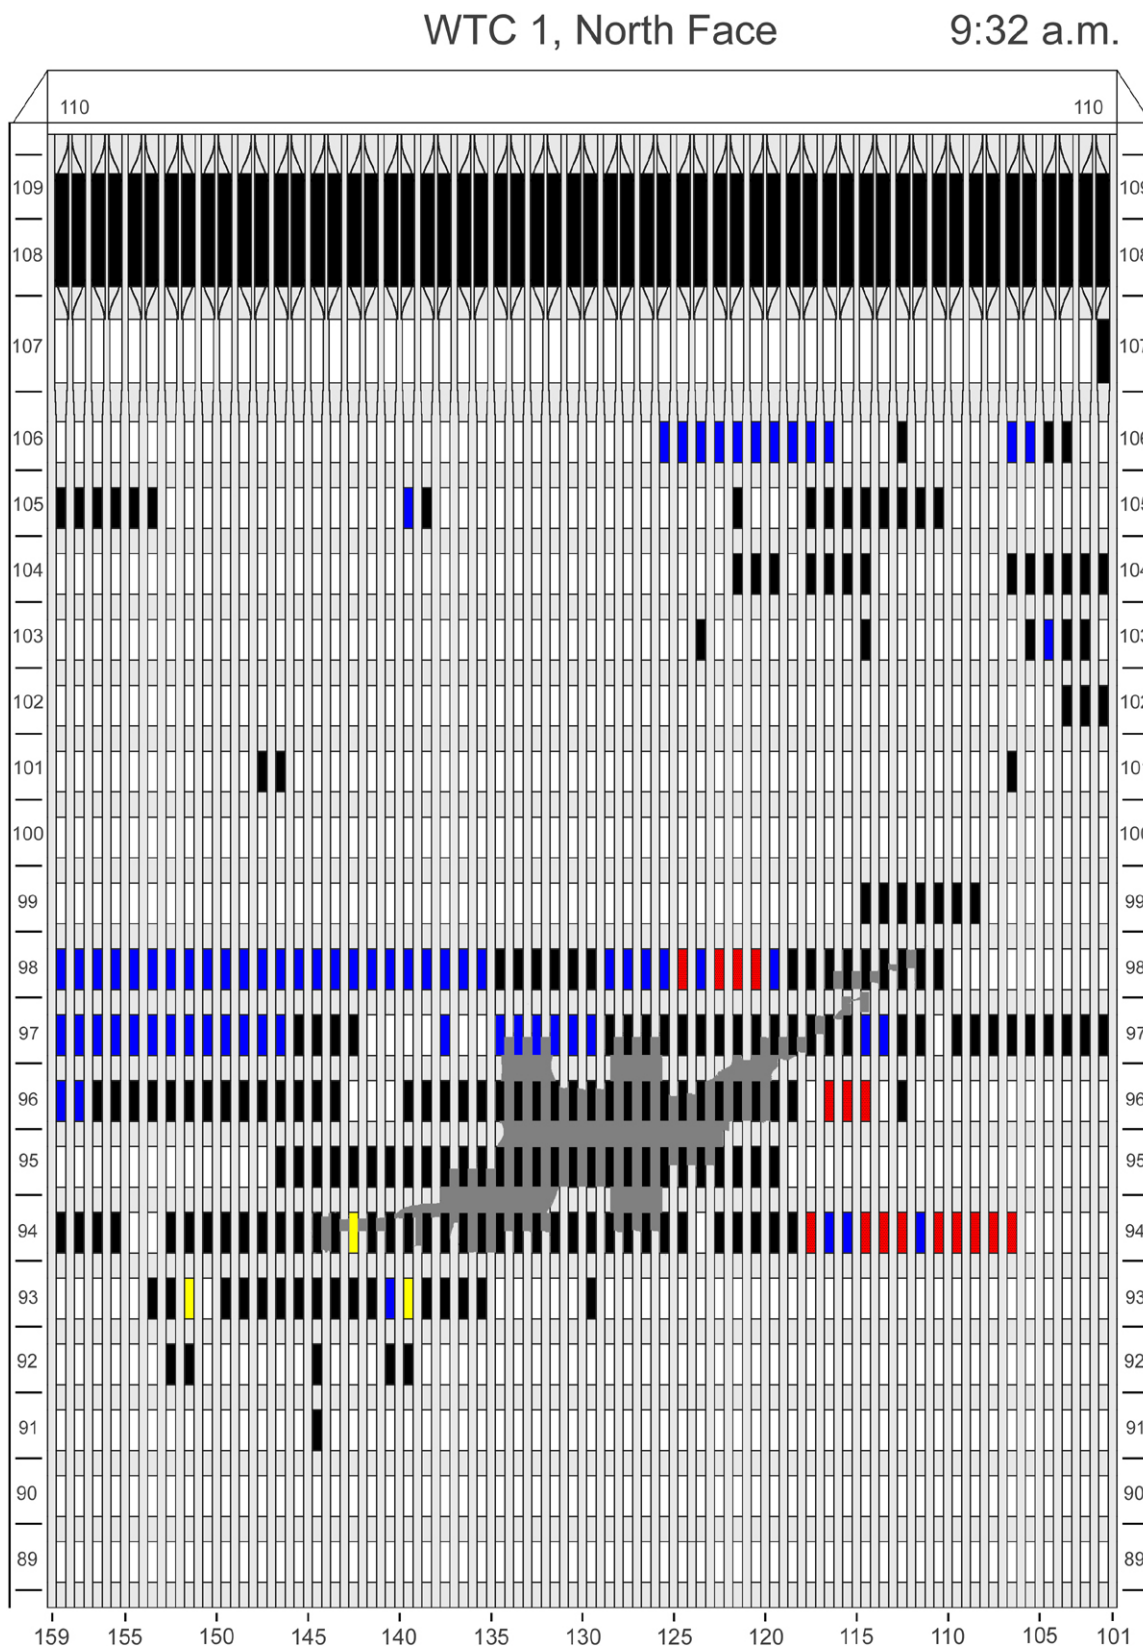
**Figure C-31. Diagram of the north face of WTC 1 for floors 89 to 110 at 9:32 a.m. showing the condition of windows and locations of fires.**

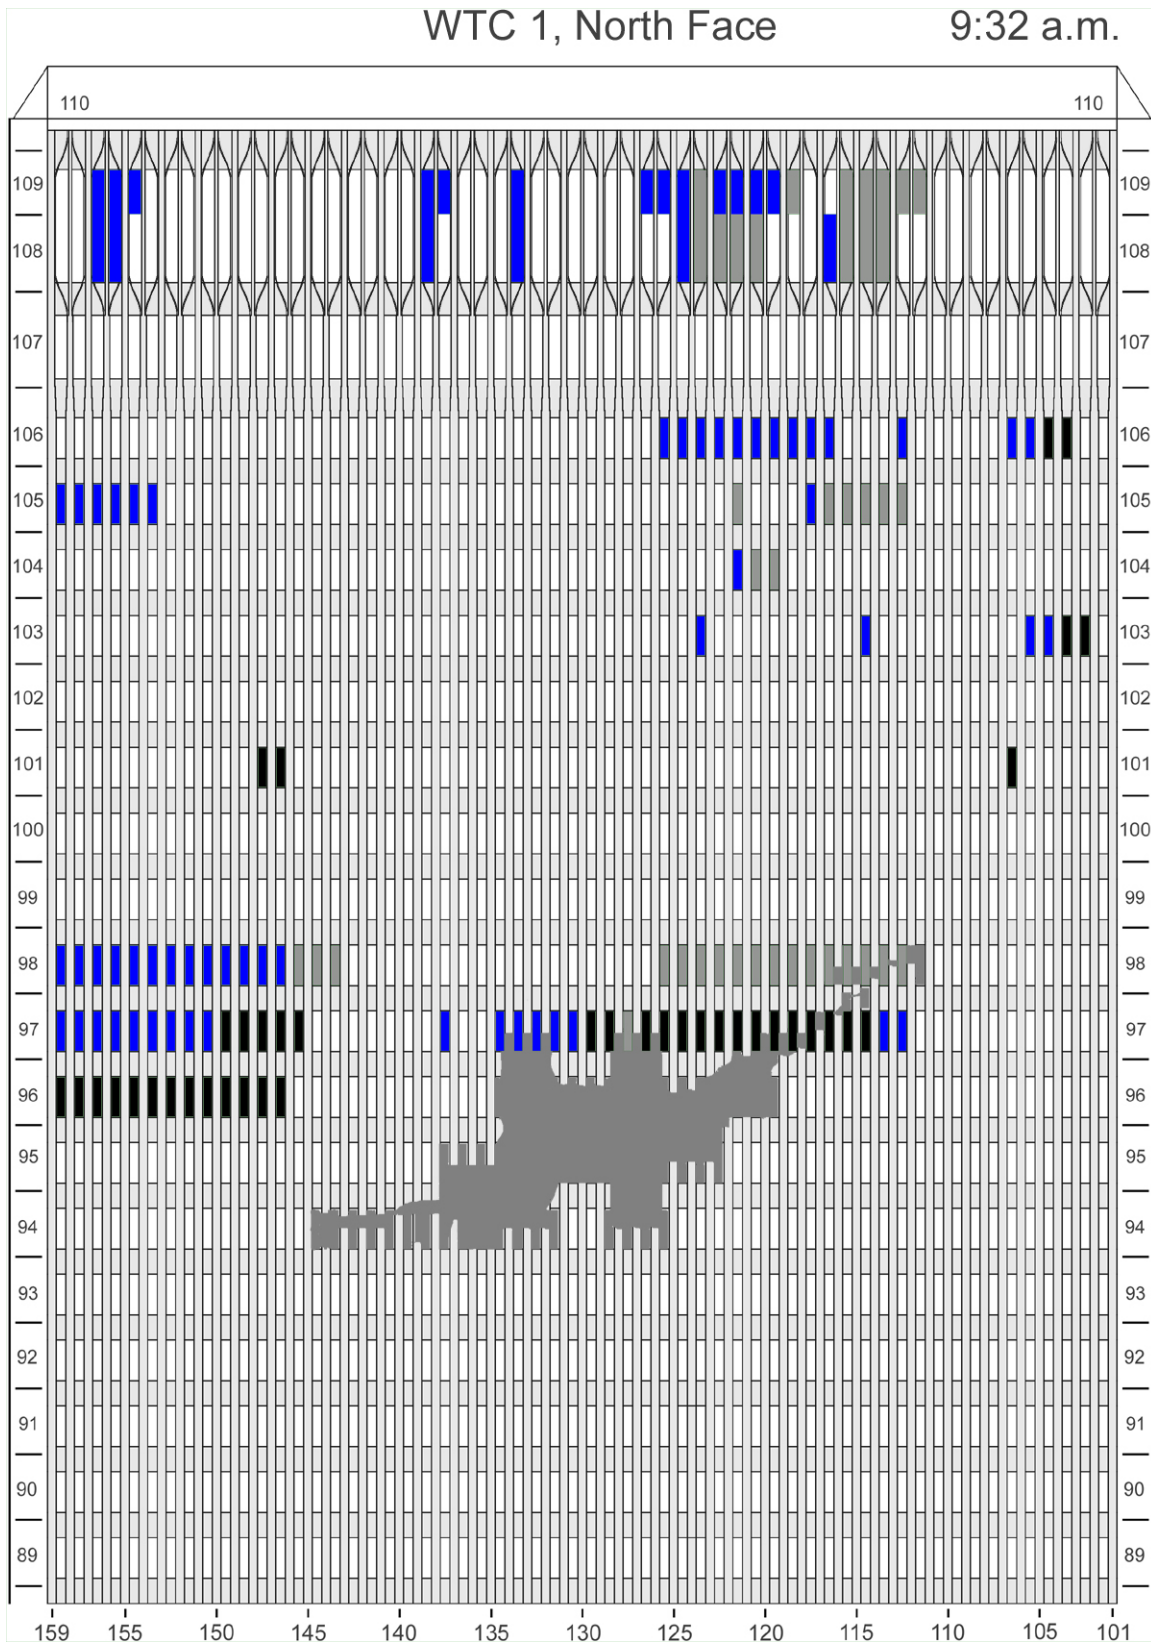
**Figure C-32. Diagram of the north face of WTC 1 for floors 89 to 110 at 9:32 a.m. showing windows where smoke was observed and those that were hidden from view.**

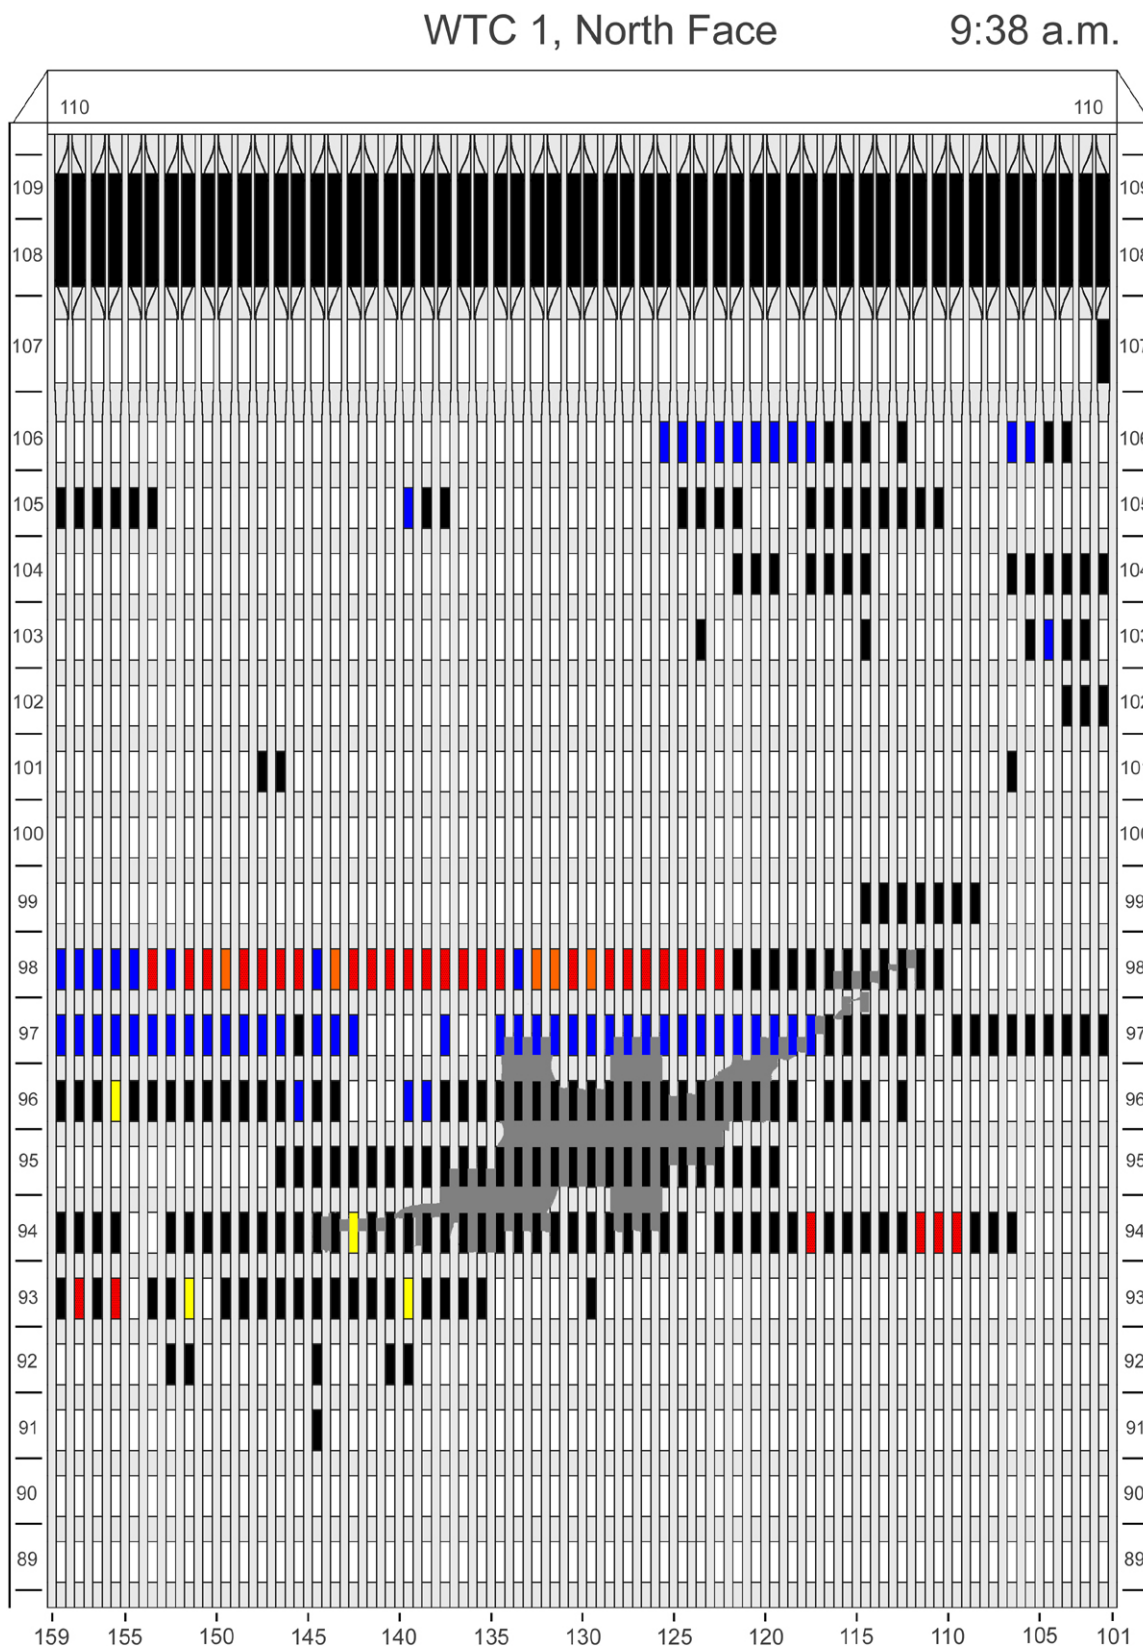
**Figure C-33. Diagram of the north face of WTC 1 for floors 89 to 110 at 9:38 a.m. showing the condition of windows and locations of fires.**

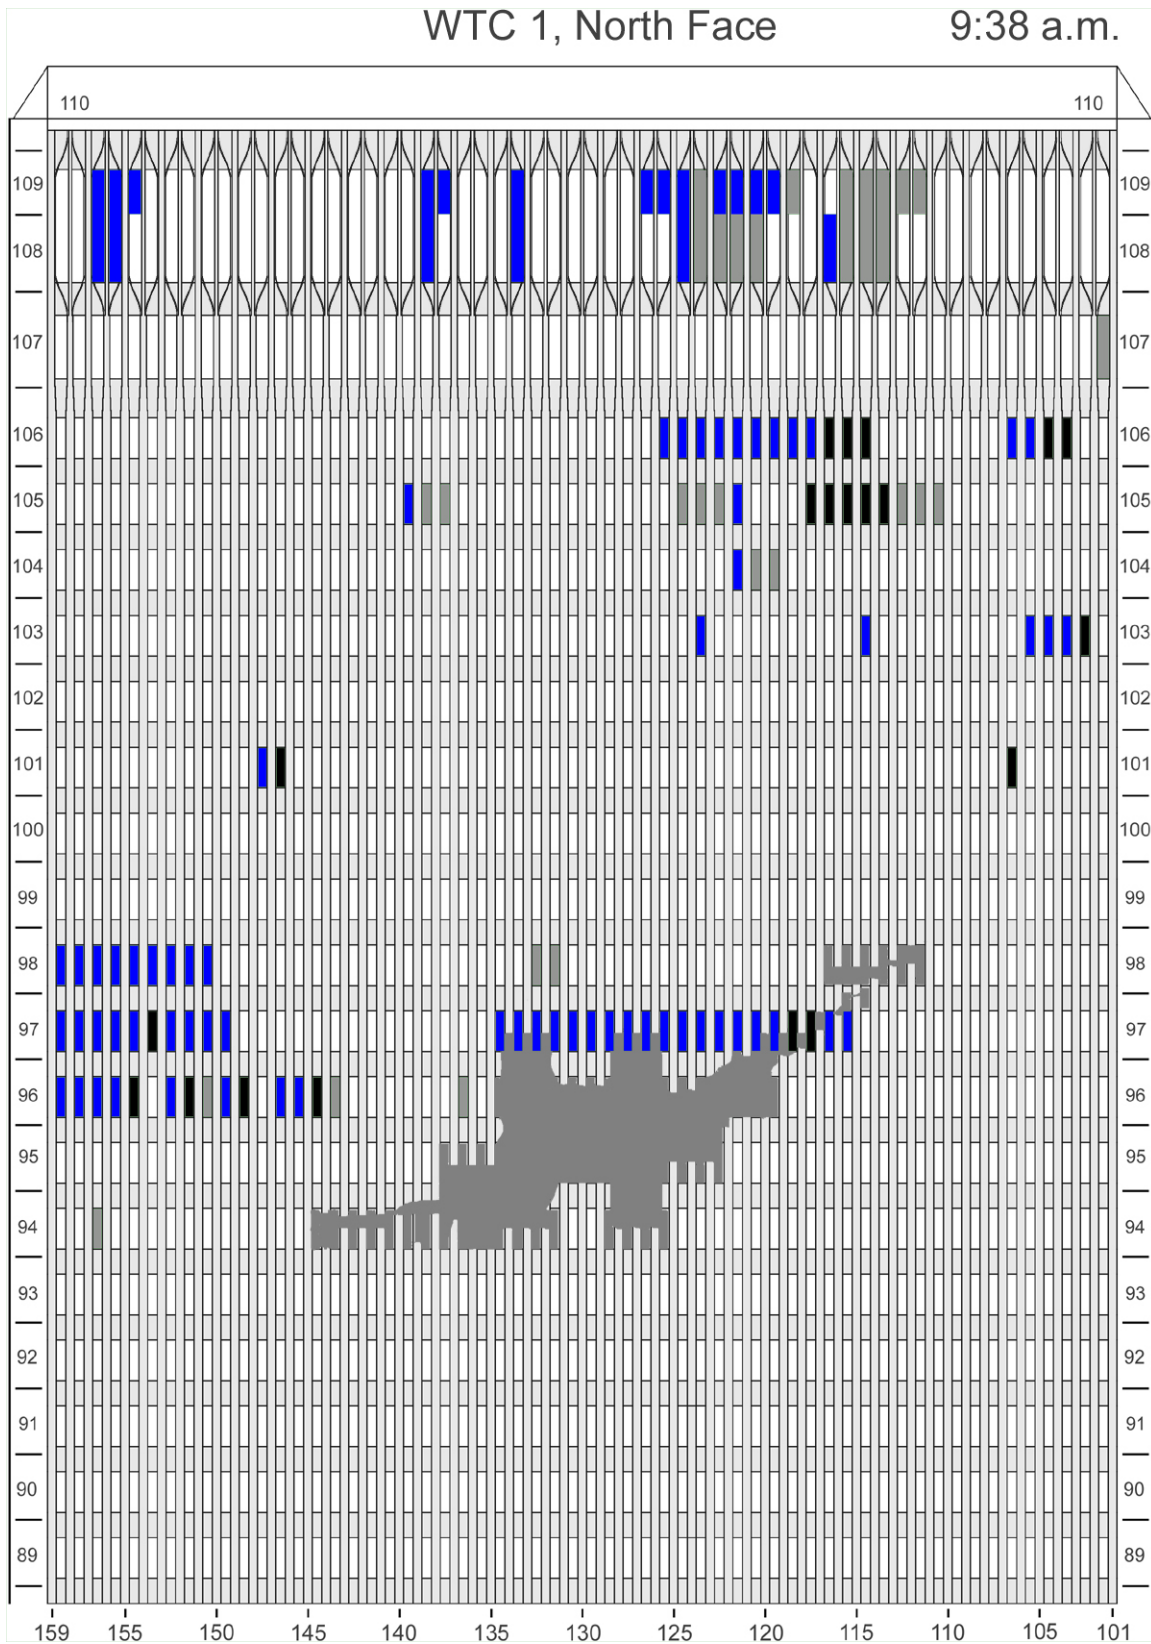
**Figure C-34. Diagram of the north face of WTC 1 for floors 89 to 110 at 9:38 a.m. showing windows where smoke was observed and those that were hidden from view.**

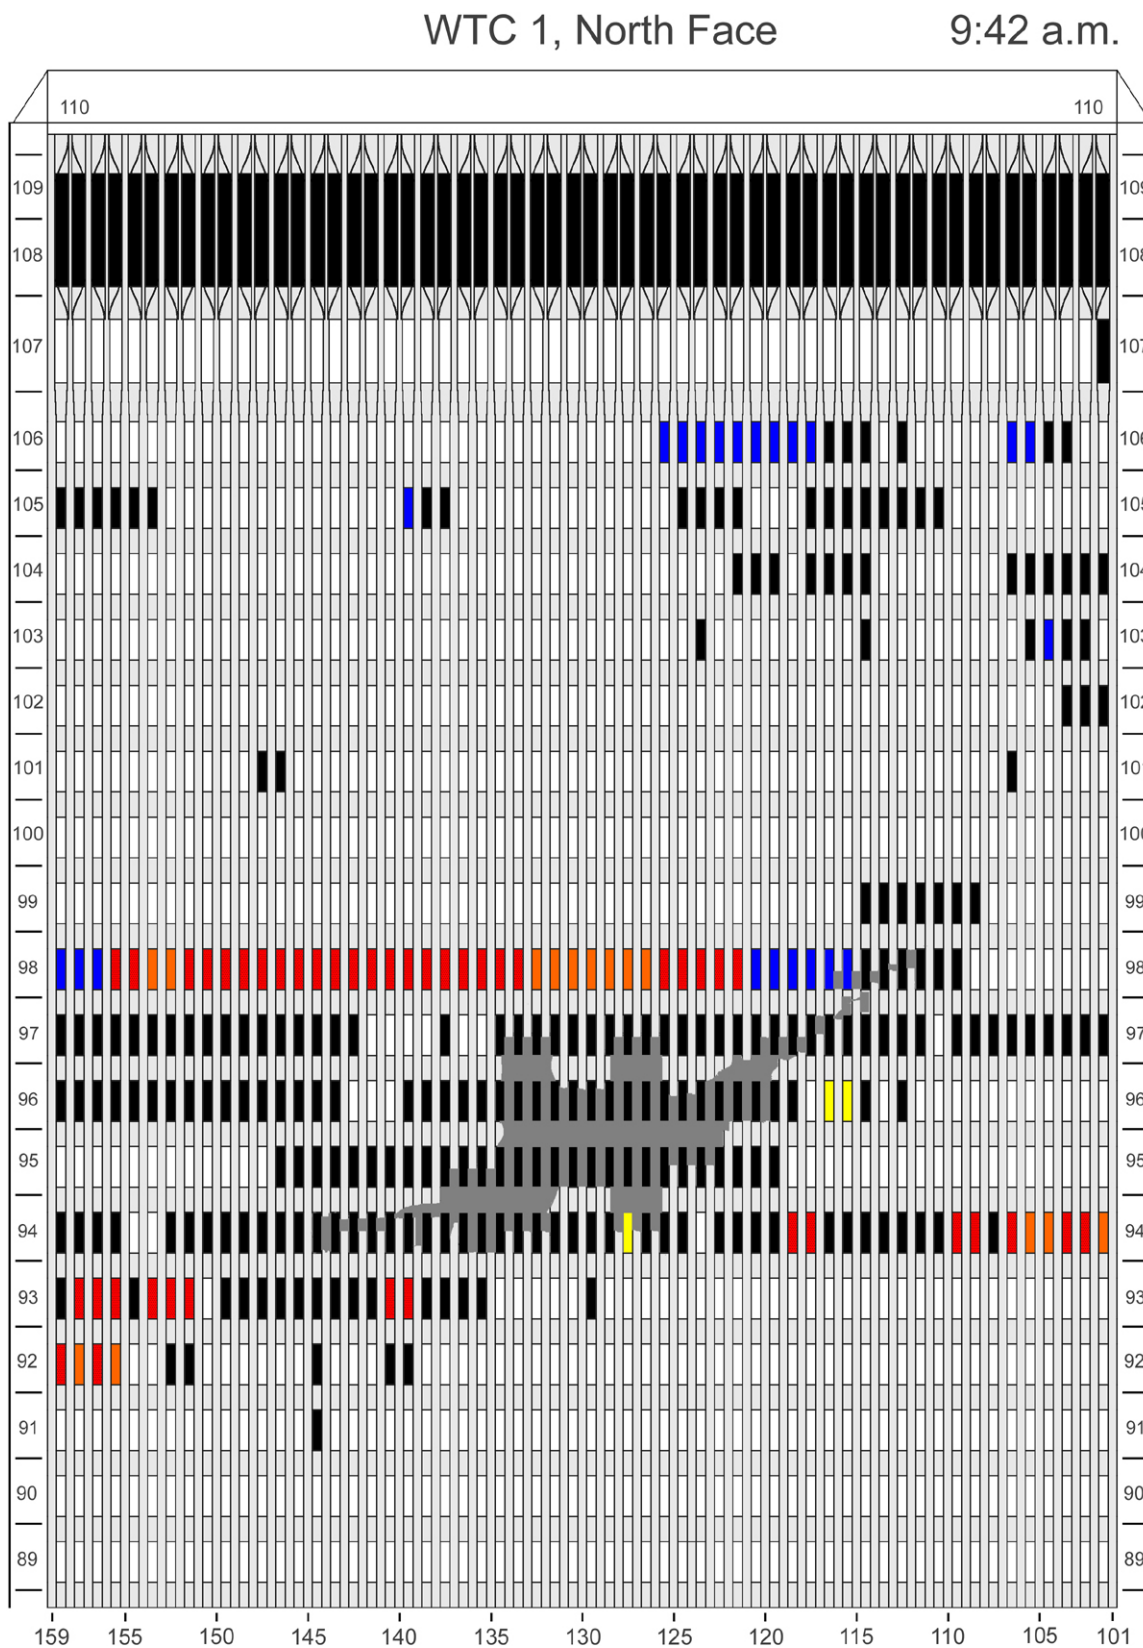
**Figure C-35. Diagram of the north face of WTC 1 for floors 89 to 110 at 9:42 a.m. showing the condition of windows and locations of fires.**

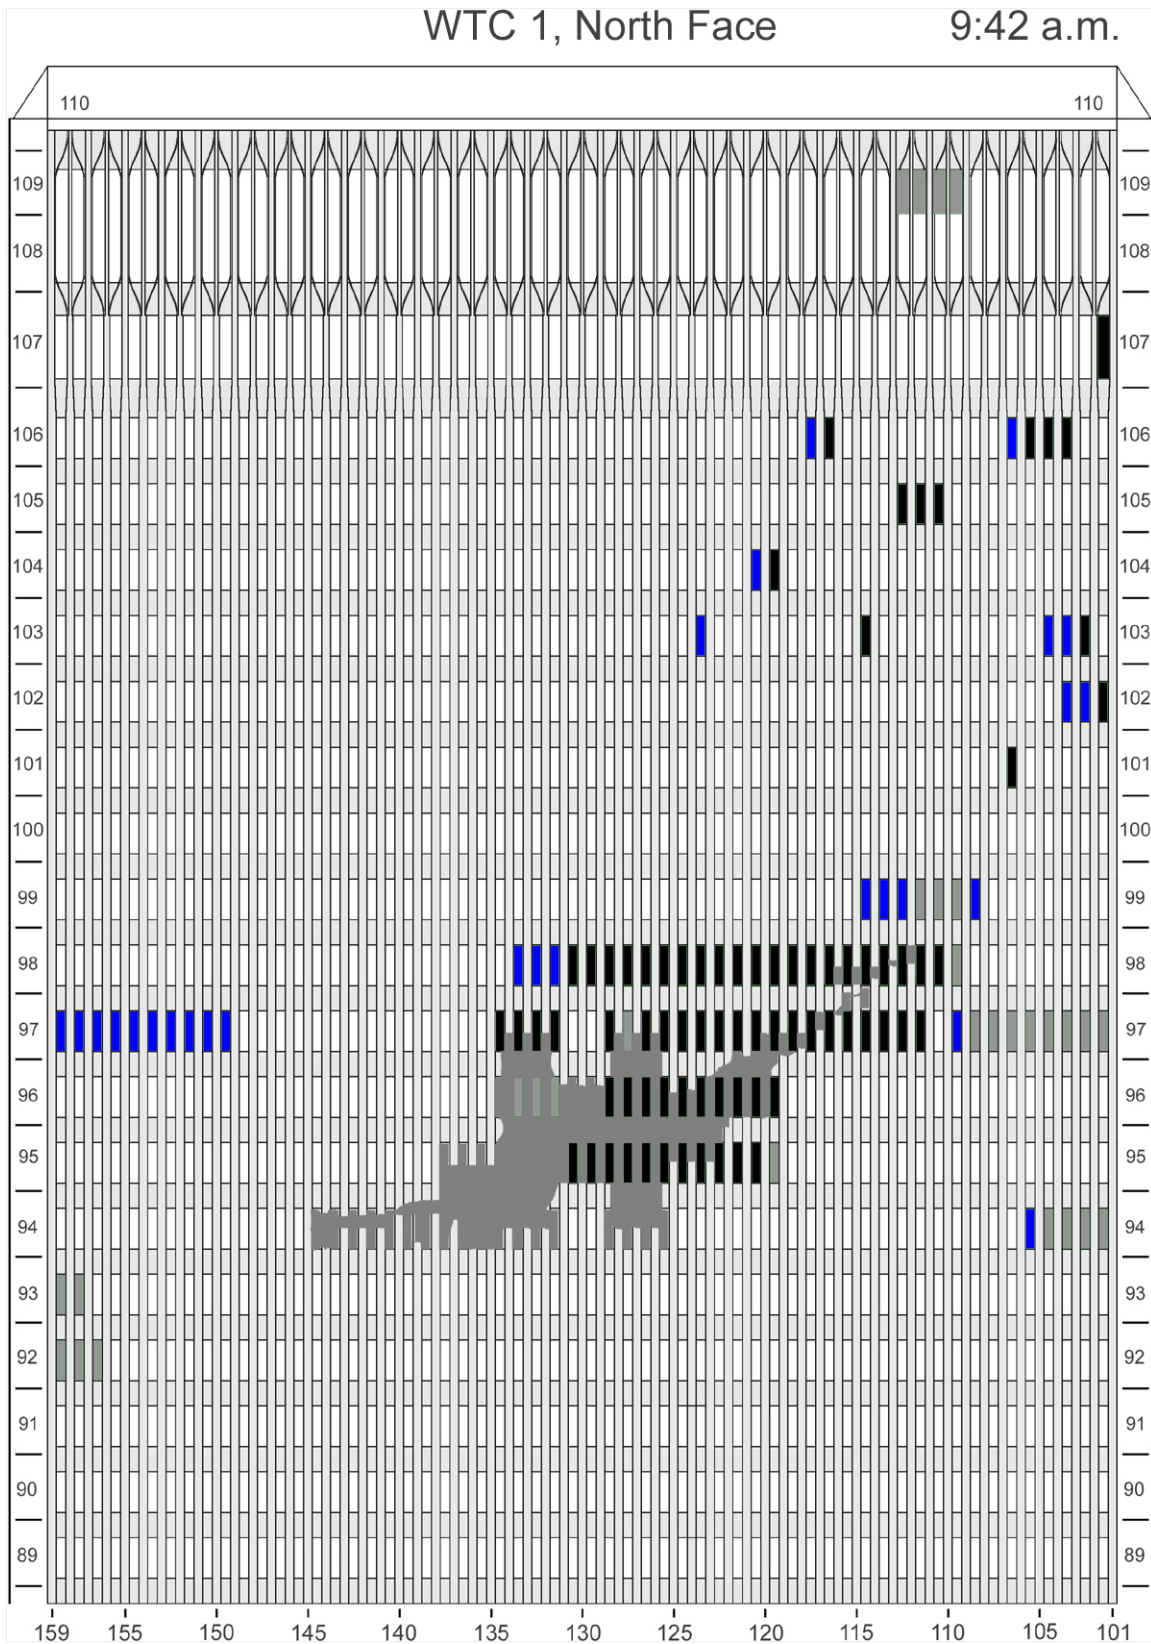
**Figure C-36. Diagram of the north face of WTC 1 for floors 89 to 110 at 9:42 a.m. showing windows where smoke was observed and those that were hidden from view.**

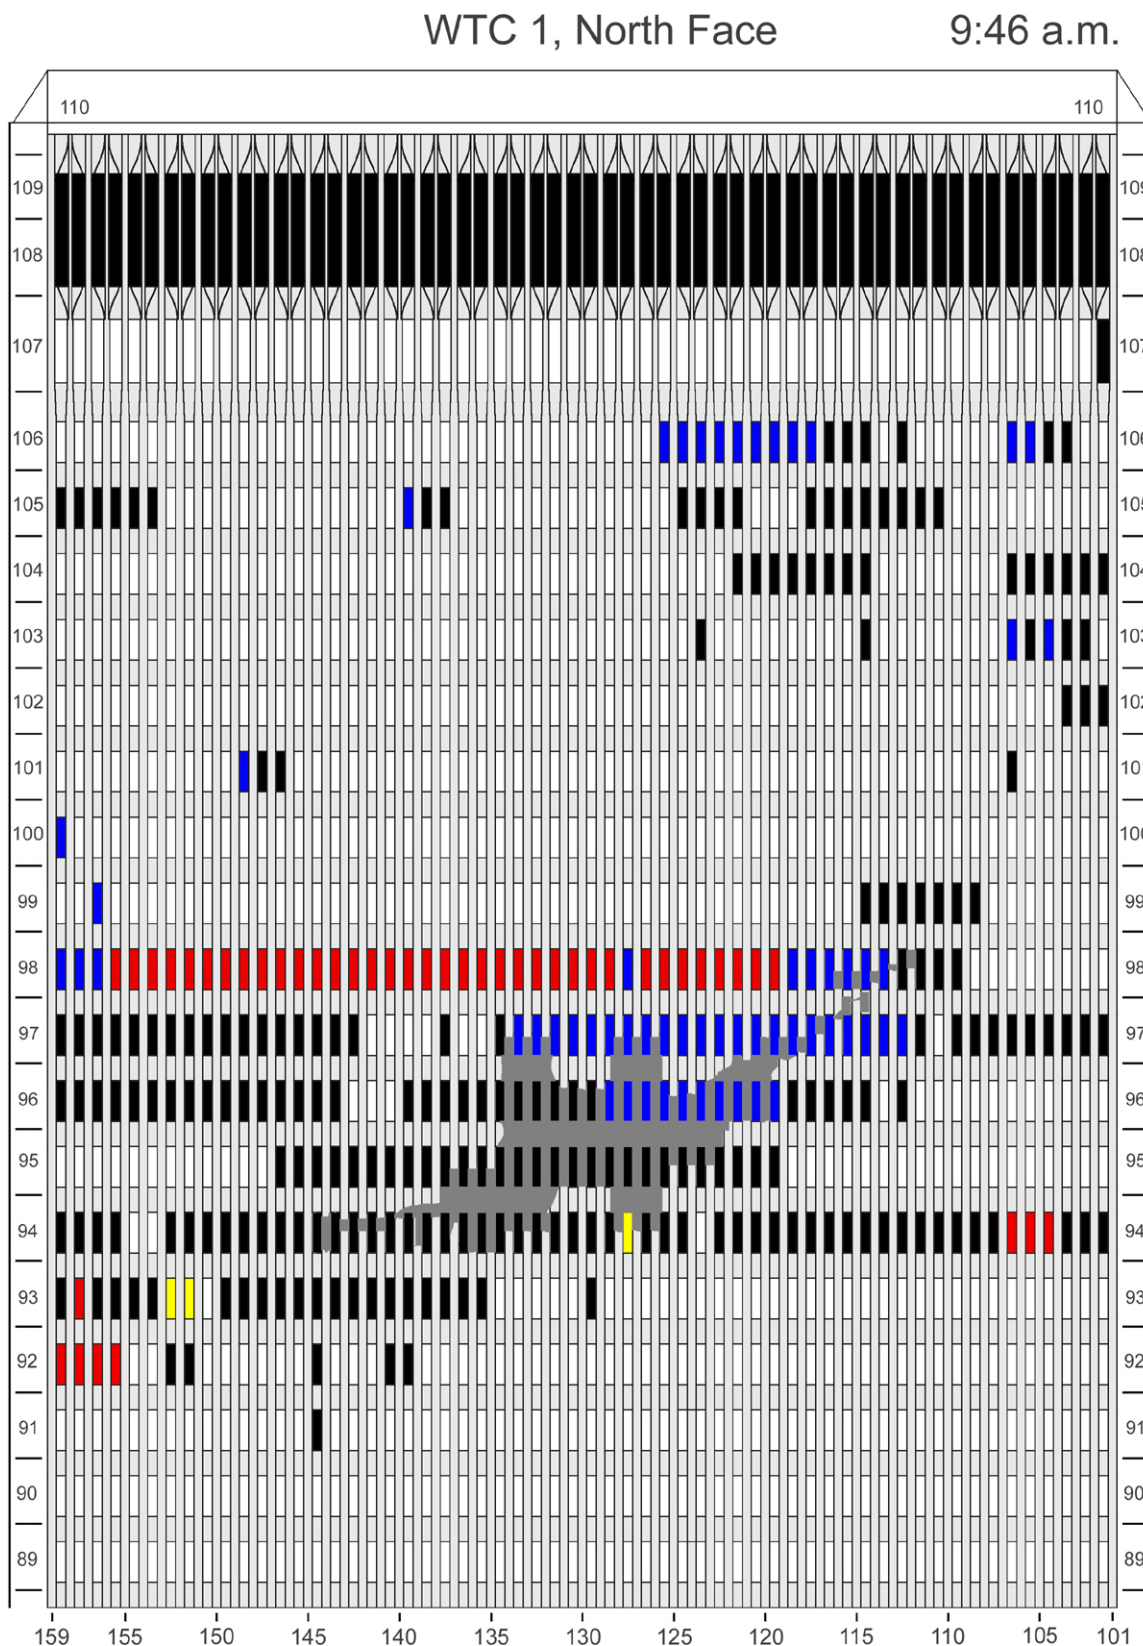
**Figure C-37. Diagram of the north face of WTC 1 for floors 89 to 110 at 9:46 a.m. showing the condition of windows and locations of fires.**

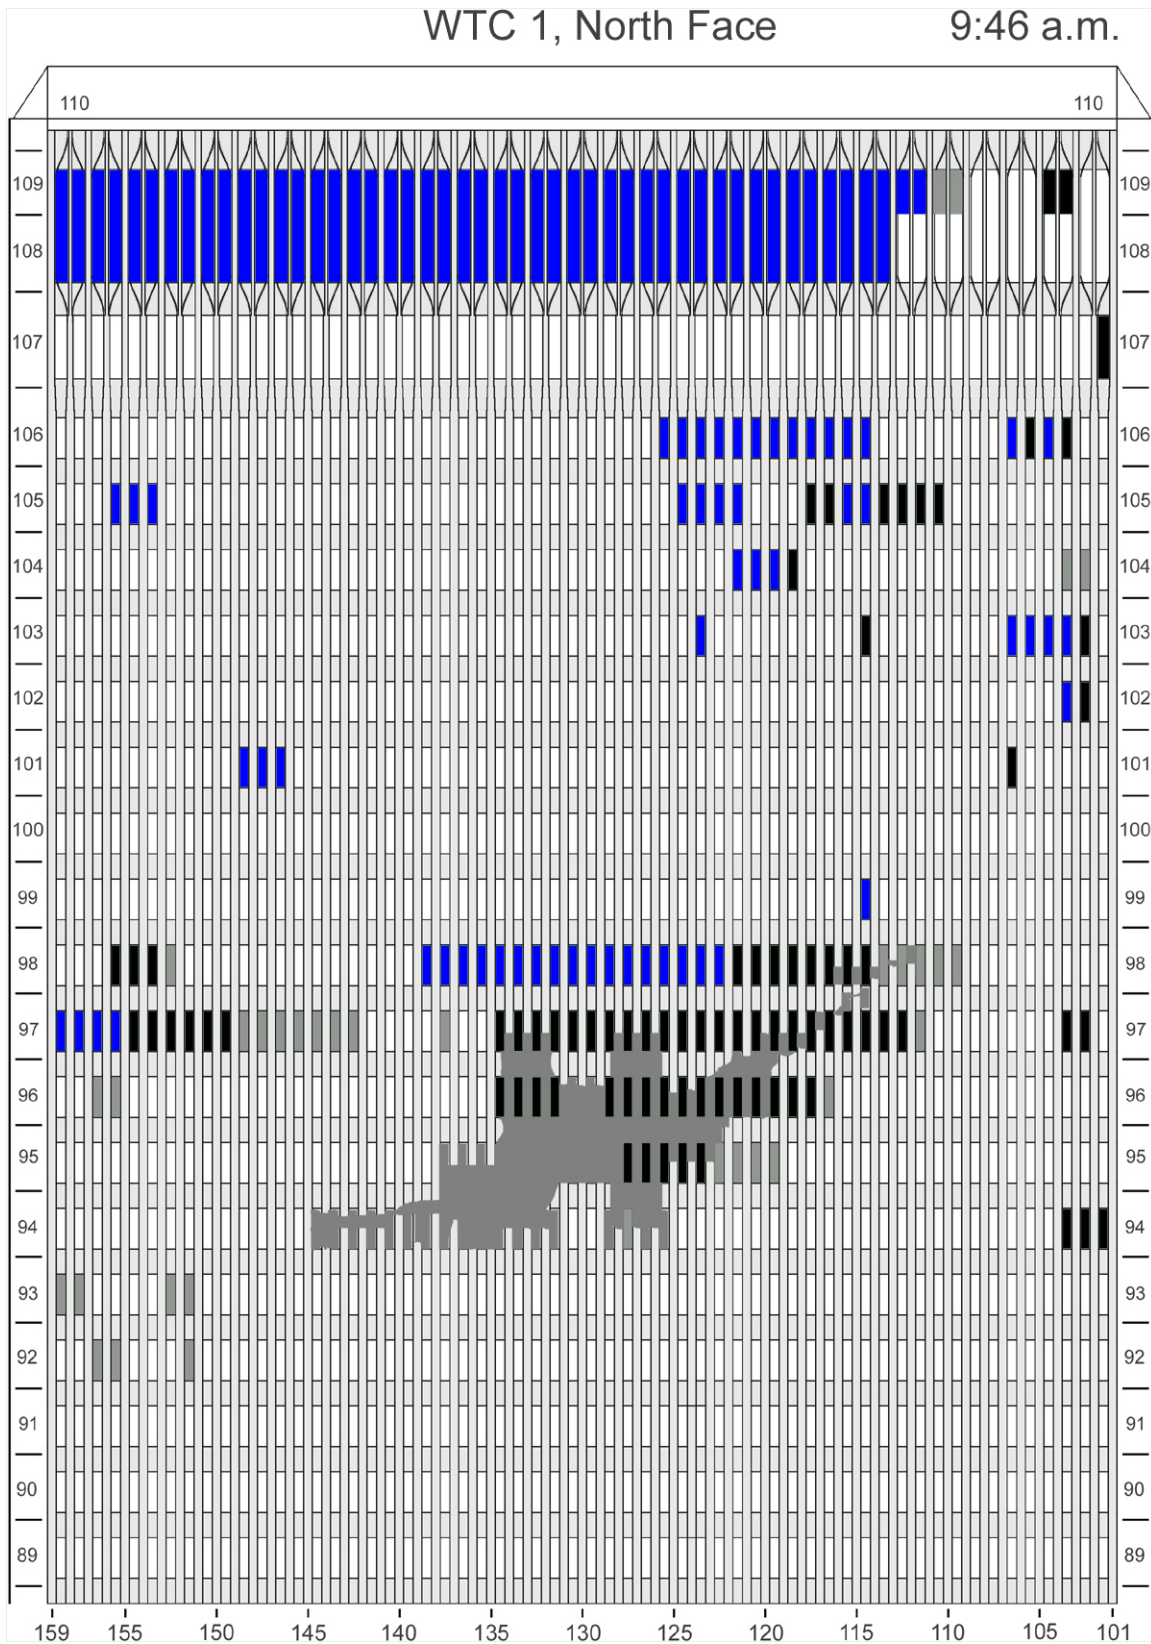
**Figure C-38. Diagram of the north face of WTC 1 for floors 89 to 110 at 9:46 a.m. showing windows where smoke was observed and those that were hidden from view.**

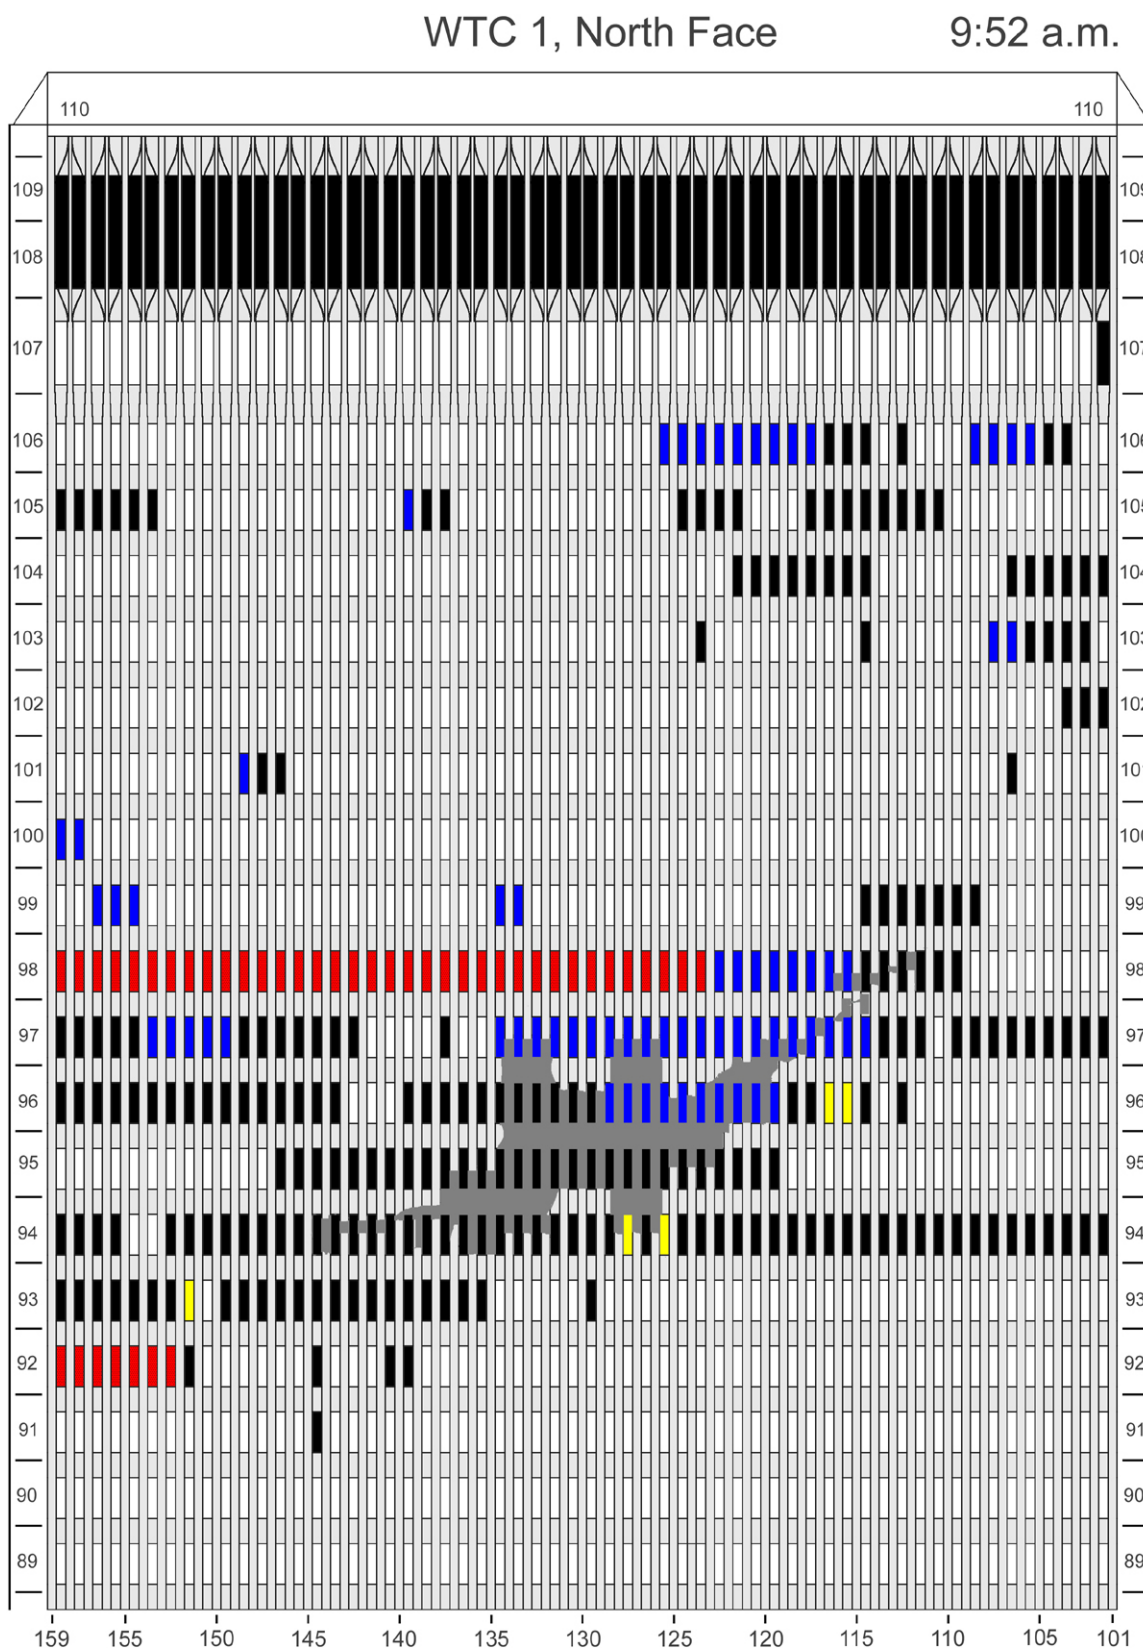
**Figure C-39. Diagram of the north face of WTC 1 for floors 89 to 110 at 9:52 a.m. showing the condition of windows and locations of fires.**

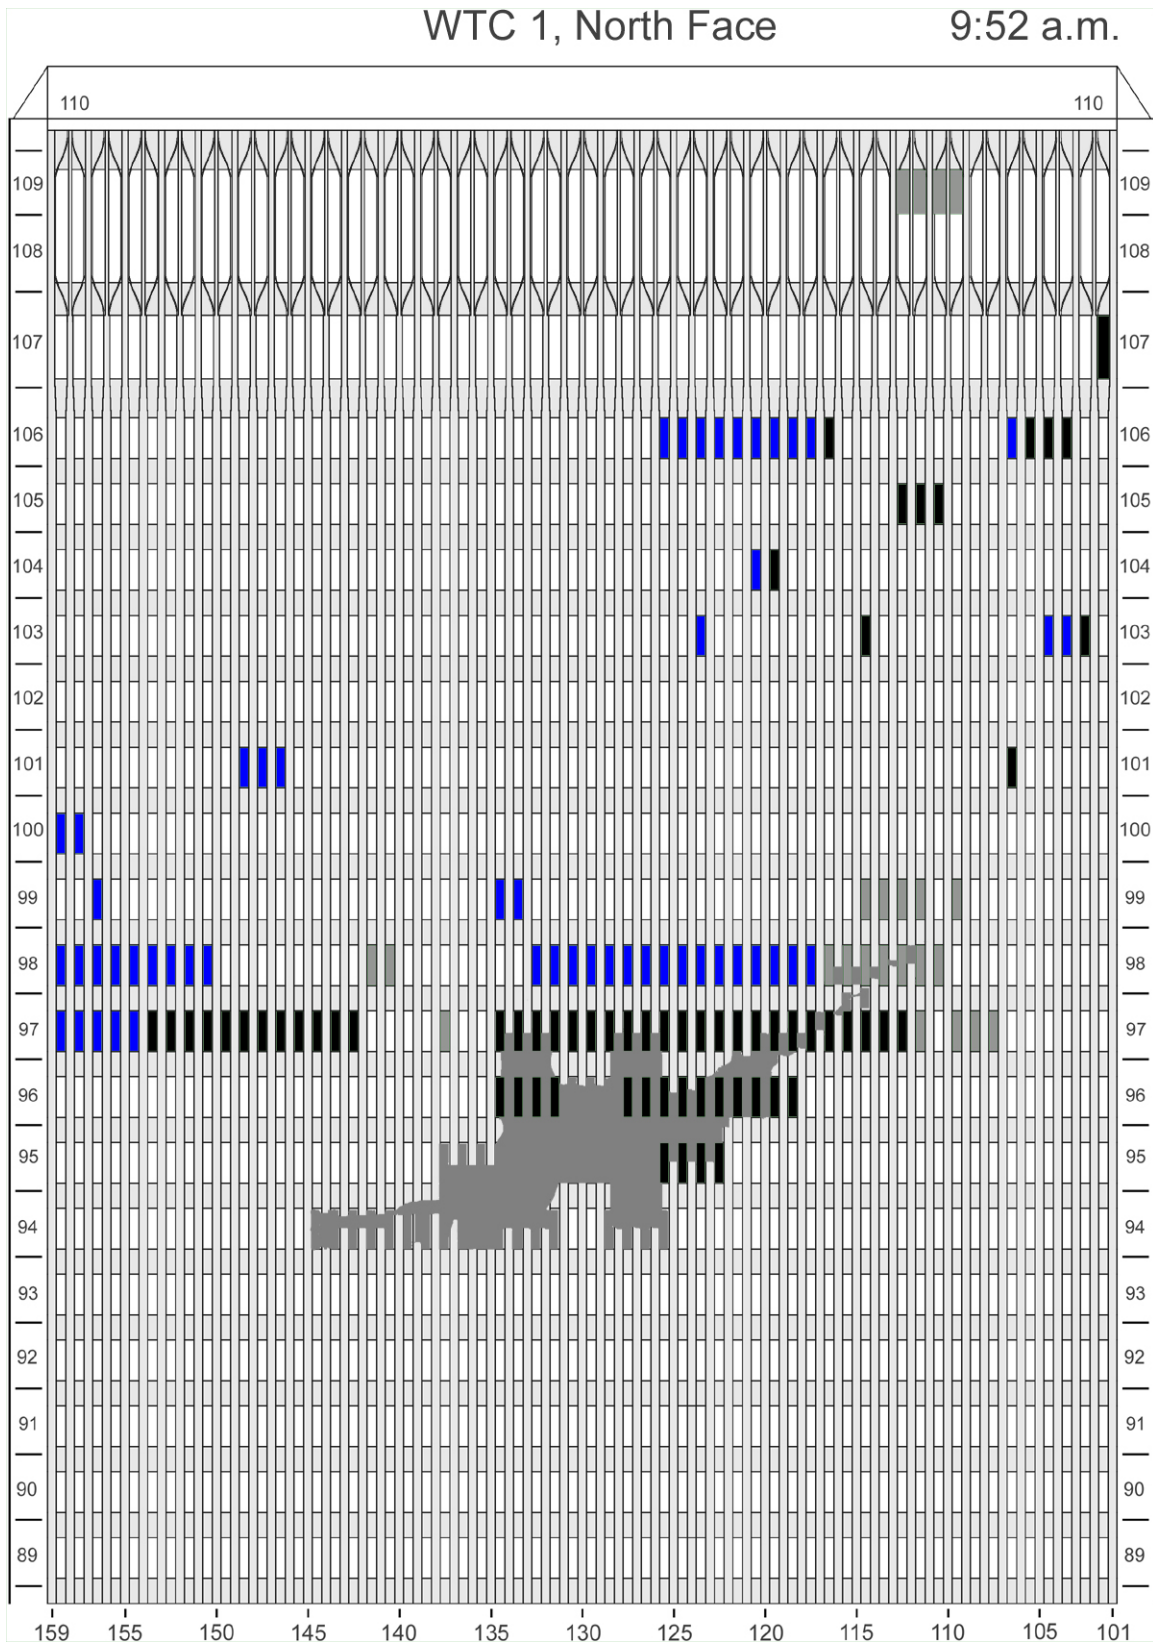
**Figure C-40. Diagram of the north face of WTC 1 for floors 89 to 110 at 9:52 a.m. showing windows where smoke was observed and those that were hidden from view.**

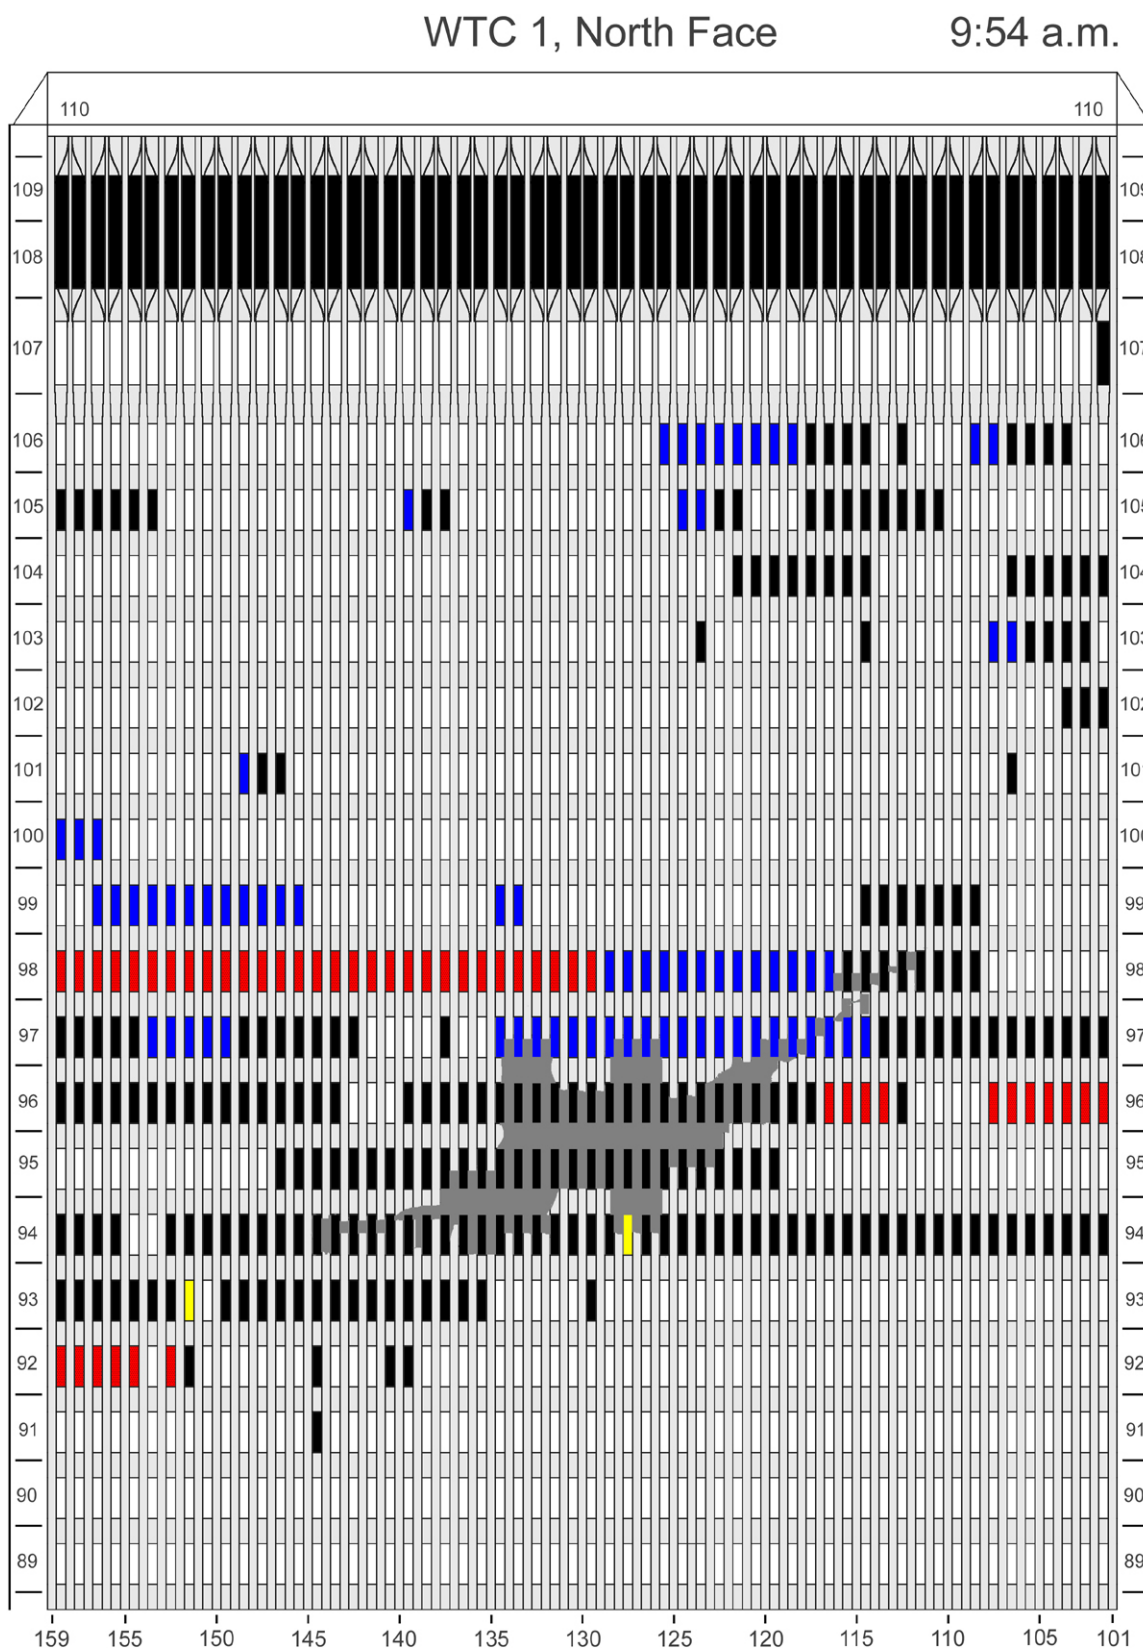
**Figure C-41. Diagram of the north face of WTC 1 for floors 89 to 110 at 9:54 a.m. showing the condition of windows and locations of fires.**

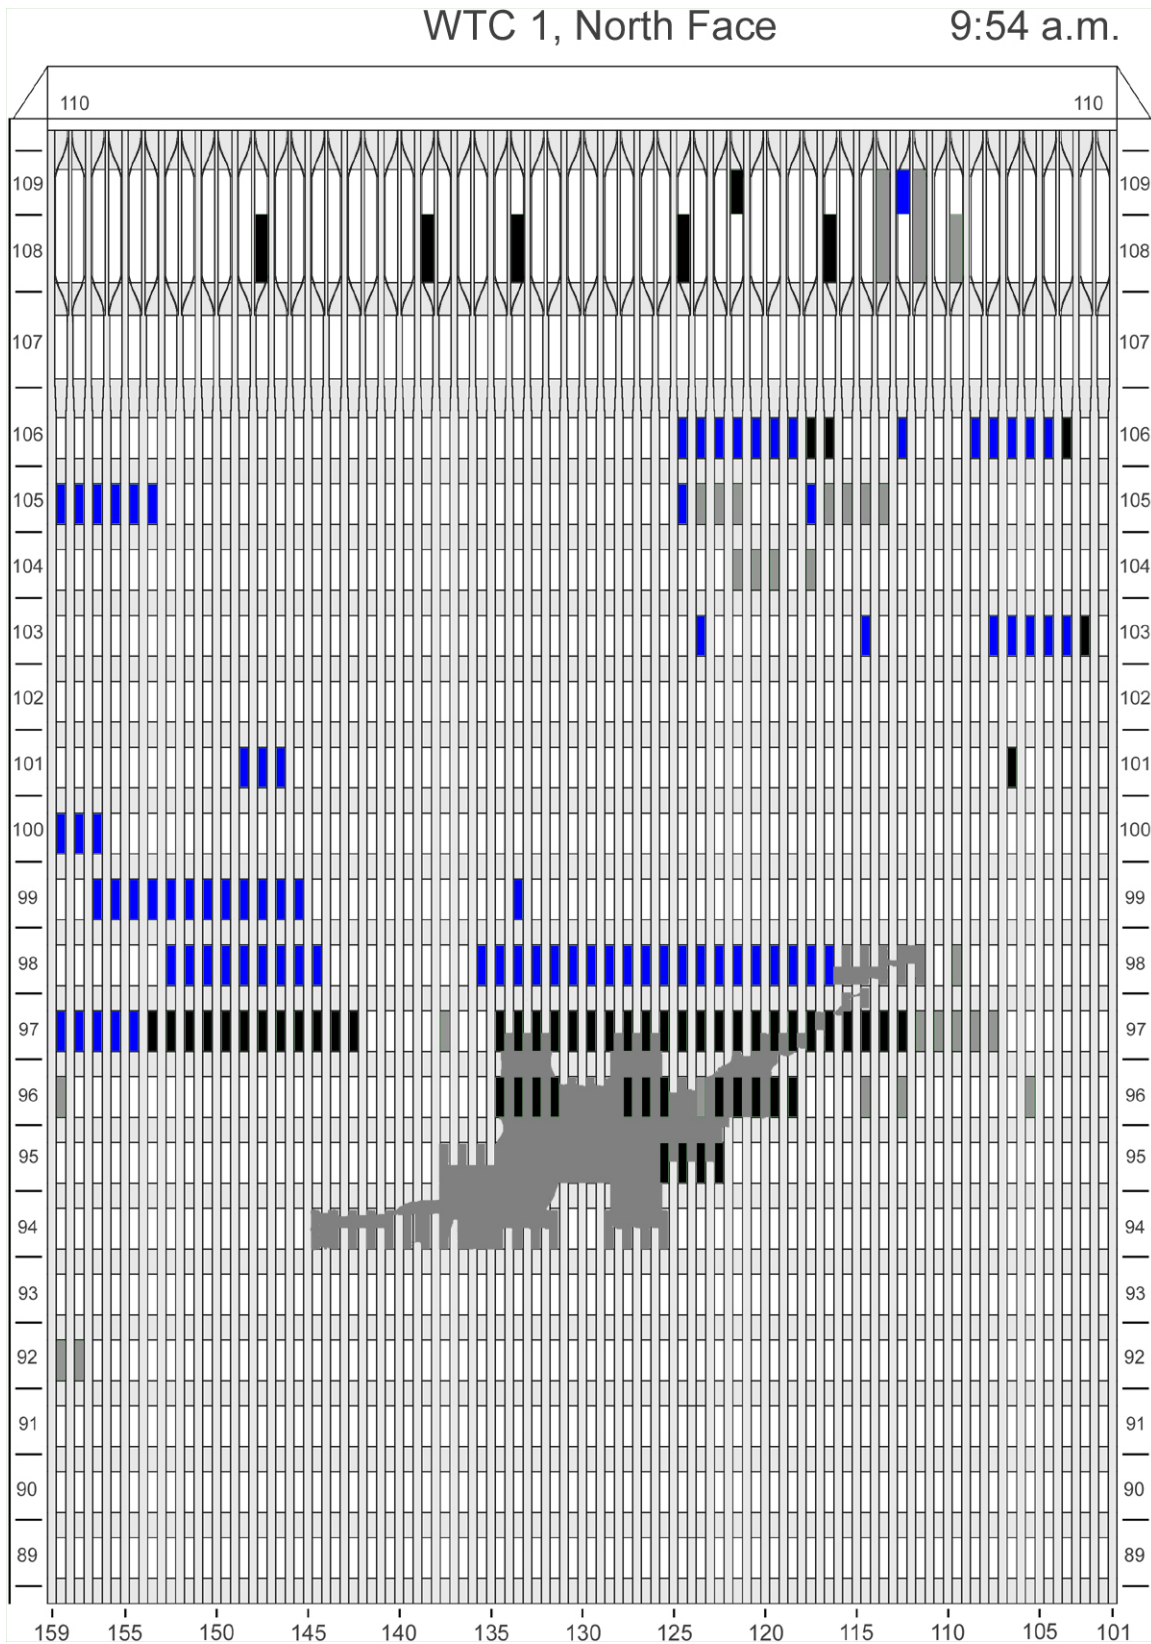
**Figure C-42. Diagram of the north face of WTC 1 for floors 89 to 110 at 9:54 a.m. showing windows where smoke was observed and those that were hidden from view.**
